**South Lake Recreational Water and
Sewer District—West Mountain Area
Onsite Wastewater System Report
January 2026**

**This document was prepared with support from Eastern Research Group, Inc. and MDB, Inc.
under U.S. EPA contract number 68HERC23D0001.**

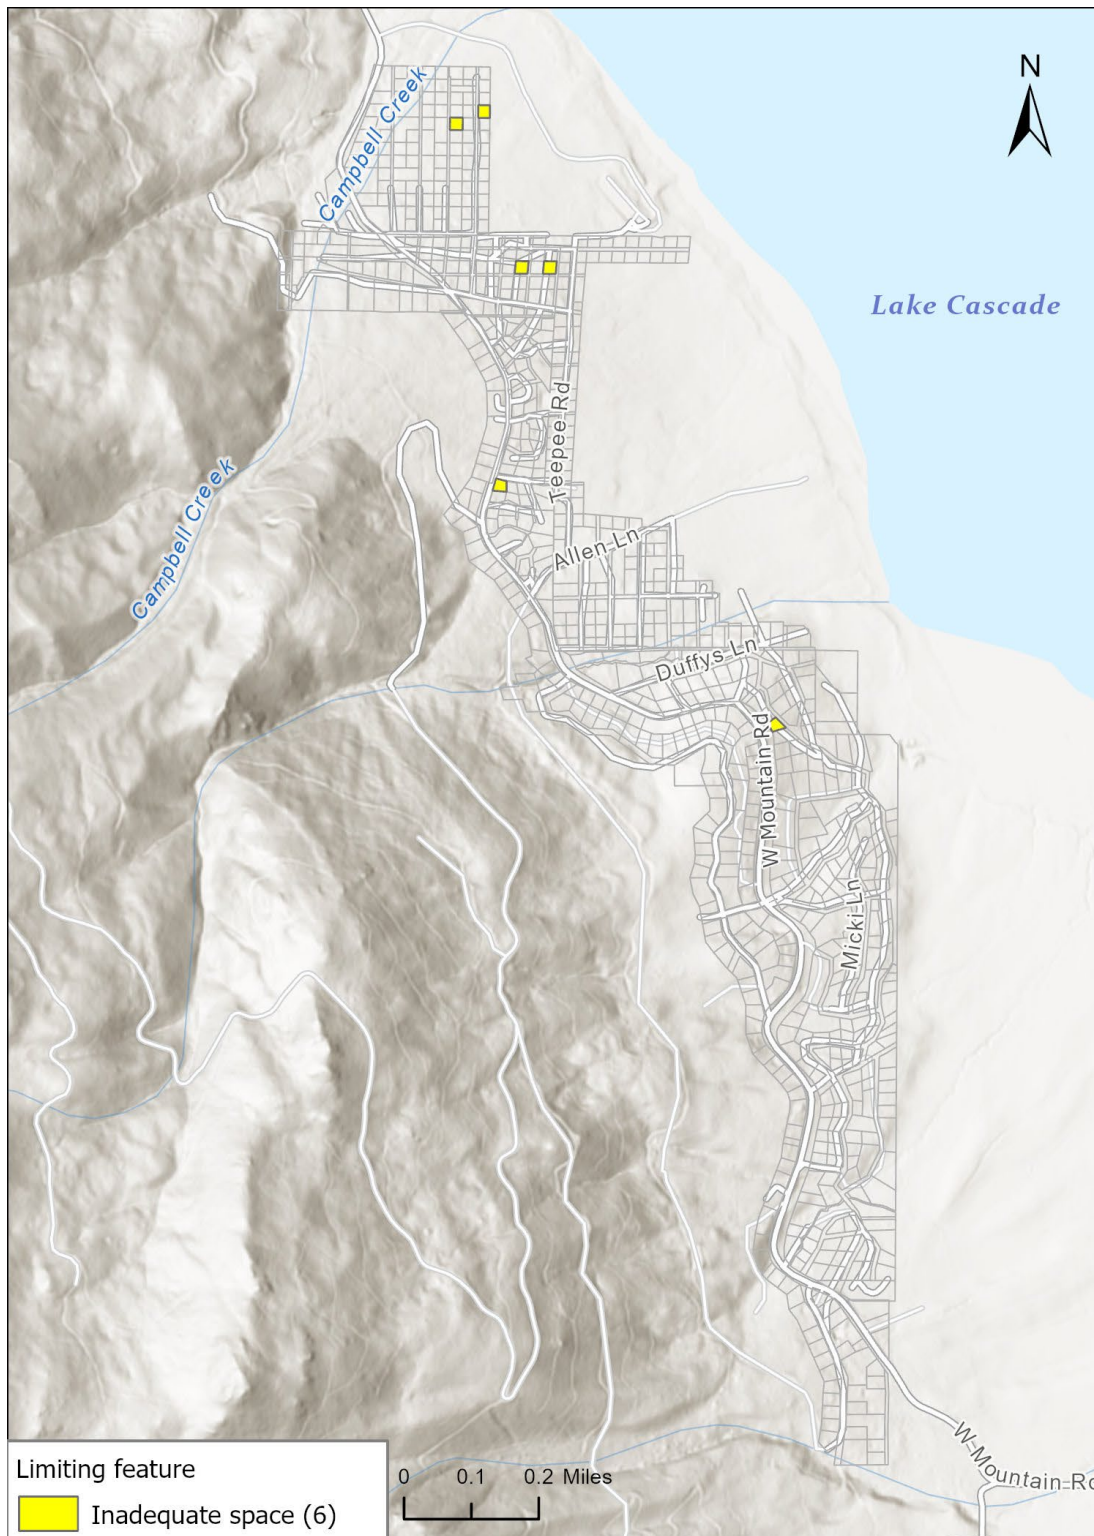
Figure 7. Onsite systems denied due to inadequate space.
